Landscaping with BioD-Block™ coir block system

RoLanka International, Inc. 2004

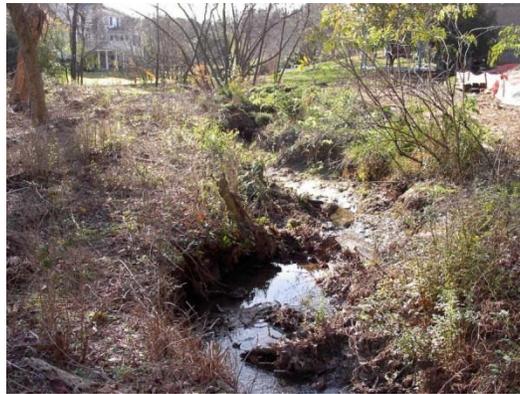
This unnamed tributary of Peavine creek in DeKalb County, Georgia drains a 4 acre wetland, as well as handles large amounts of storm water periodically. This stream bank restoration project required the grading and stabilizing of approximately 150 linear feet of stream on both sides. Prior to construction, the stream bank profile was severely undercut and numerous places exhibited bank failure. The stream experiences periodic high water and overflow of banks in heavy rains. The goal of this project was to establish an appropriate slope on both sides of the stream that would allow stabilization of banks using boulders and plantings, and at the same time maintain the current hydrology of the area.

Eroded creek

We chose the BioD-Block coconut fiber block system manufactured by RoLanka International to use to rebuild the stream banks and establish a 3:1 slope. The 16” tall, flexible coir block made installation much quicker and more uniform. We were able to maintain the appropriate elevation during installation, as well as the natural meanders of the stream much more easily. We were also able to overlap and connect the rolls securely with the male and female end of coir blocks. In addition to the BioD-Block coir block system, we used many tons of small and medium size boulders throughout the length of the stream to add a more natural look and to add protection to vulnerable erosion areas. We used BioD- Mesh60 woven mattress coir blanket on the upper half of the stream bank in order to help hold the soil while plants establish.

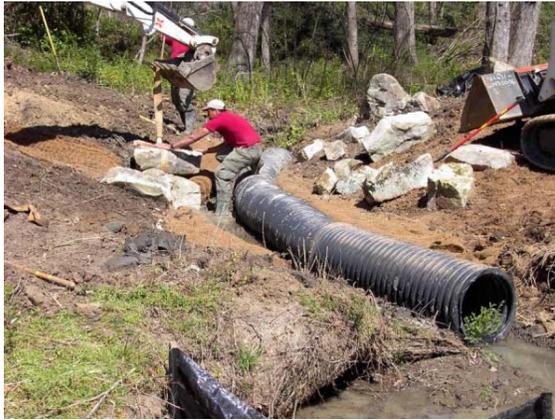
During installation

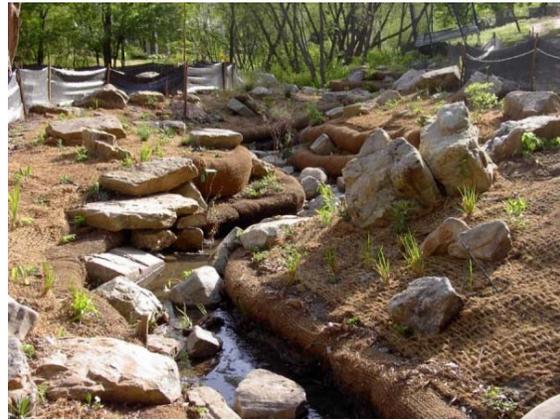
After installation

Once the stream bank work was completed, the area was planted with herbaceous plugs and woody plants up to 1 gallon in size. The project was finished in May of 2004. Through heavy and unseasonably abundant rains this spring and early summer, the coir blocks and blankets have held up well and the plants are becoming well established.
