Coir Fibers Add Natural Strength and Durability to Lake Shore Stabilization Project

RoLanka International, Inc.

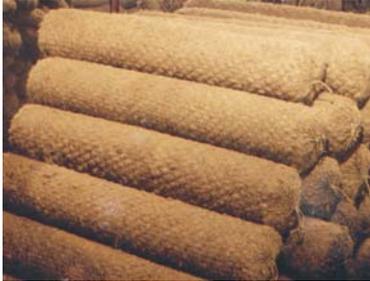
Densely packed coir rolls

- Coir rolls would provide initial bank stability until roots of woody species could establish a network of roots to hold the soil in place. The coir fiber cores of the rolls support the growth of trees and shrubs which are planted next to them. In time, sediment deposited by wave action around the coir rolls provides a growth medium for the vegetation.
- Coir blocks would be used to construct fabric-wrapped layers of compacted soil to stabilize the higher banks and areas subject to stronger wave forces. They offer a faster, easier approach to constructing encapsulated soil lifts than conventional geotextile fabrics.
- Structures made of imbricated stones would protect water access sites.
- The areas between the stabilized shoreline and the asphalt walkway would be seeded with tall fescue mixture to control erosion from stormwater runoff.

Prior to installing the rolls, the slopes were reshaped to gradients of 3H:1V to 4H:1V for improved long-term bank stability and easier installation of the rolls. Two adjacent rolls were installed along 1,775 linear ft. of lake’s perimeter and three rolls were placed side by side along 1,125 linear ft. of the higher banks of the islands. They were held in place using 3-ft. long, 2 x 2-in. wood stakes.

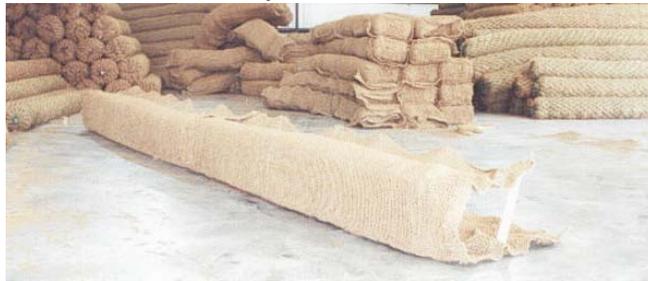
Coir Block System

This system features a 10-ft.-long, densely-packed block of elongated coir fiber measuring 16 in. high and 9 in. wide. A woven coir fabric is wrapped tightly around and secured to the block. Depending on the type of block, this fabric extends back 16 to 48 in. from the top and 28 to 75-in. from the bottom. When installed, the outside of the block forms the face of a 16-in high soil lift, while the fabric forms the top and bottom of the compacted, reinforced soil layer. This system features a male and female end to create a strong connection between adjacent blocks while maintaining structural integrity. Unlike conventional encapsulated soil lift construction methods, this approach usually requires no inner fabric, such as a stitched biodegradable coir blanket, and installs faster to reduce costs.

Prior to installing the coir blocks, woody materials were removed from the banks and a 16-in. diameter coir roll was installed at the base of the slope to provide additional support for the blocks. Three rows of coir blocks were then installed one above the other and setback to form a 4-ft. high mechanically stabilized earth structure along a total of 95 linear ft. of shoreline. However, with no way to efficiently transport and place large amounts of compact fill behind the coir blocks, the reinforcing layers of coir fabric were extended back about 1 ft., rather than the more typical 4 to 6 ft., to build the earth wall.

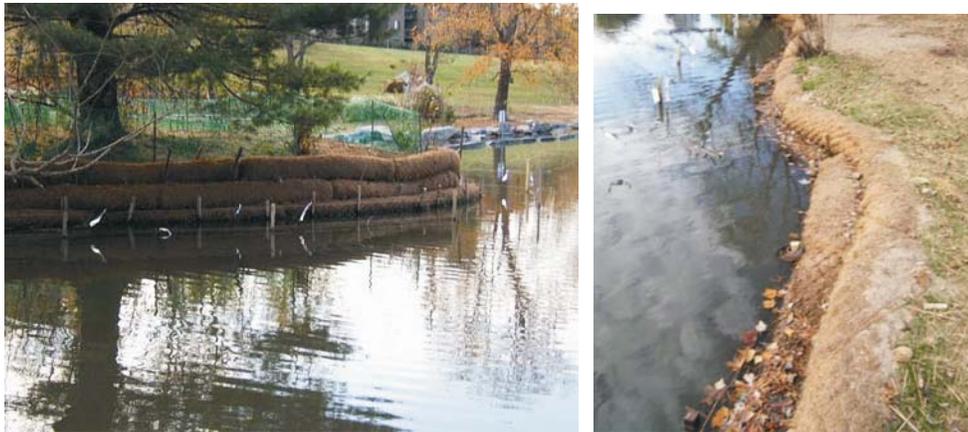
Ecotone, Inc., an environmental design and construction company in Jarrettsville, Md., installed the erosion control practices in a three-month project that began in August, 2004. The company, which works throughout the Mid-Atlantic region, has extensive experience using coir rolls (logs). For this project, the company selected BioD-Roll 40, made by RoLanka International, Inc. The 16-in. diameter, 10-ft. long roll consists of coir fiber densely packed inside a coir twine netting with 2 in. x 2 in. openings. The rolls are designed to resist erosion and support establishment of vegetation for at least five years.

“We chose the natural coir twine netting instead of a polyethylene netting because of the relatively low wave velocity and height,” says Scott McGill, co-owner of the company. “Also, the coir twine is more environmentally friendly. So, it was more suitable for the project.”
